General Landing Gear repairs and alignment for Luscombe 8 series non-silflex gear.

REWORK INSTRUCTIONS FOR ALIGNMENT OF LANDING GEAR WHEELS

Luscombe Silvaire model 8 Aircraft Type Certificate Holder

SERVICE RECOMMENDATION #4

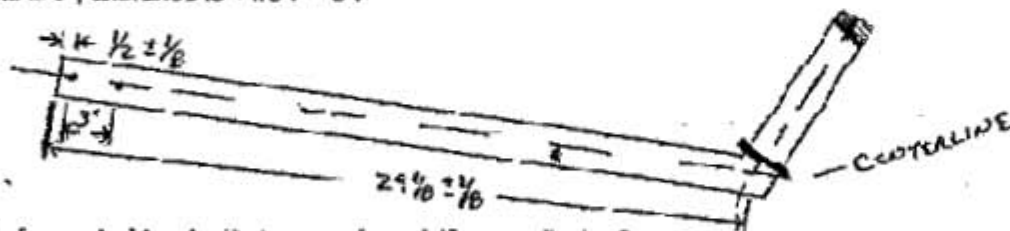
Gear dimensions

The top mounting hole is specified at 1/2" from the lower leg's top edge. Some aftermarket legs are longer or shorter requiring an adjustment of this installation dimension. Distance from the top of the lower strut (measured on the leg centerline) to the axle centerline of the gear is $29 \frac{1}{8}'' \pm \frac{1}{8}''$ for prop clearance. Distance from the top of the strut to the center of the top hole is $1/2'' \pm \frac{1}{8}''$. From Centerline of the top hole to Centerline of the bottom hole is 3", tolerance is $+1/64'' - 0''$.

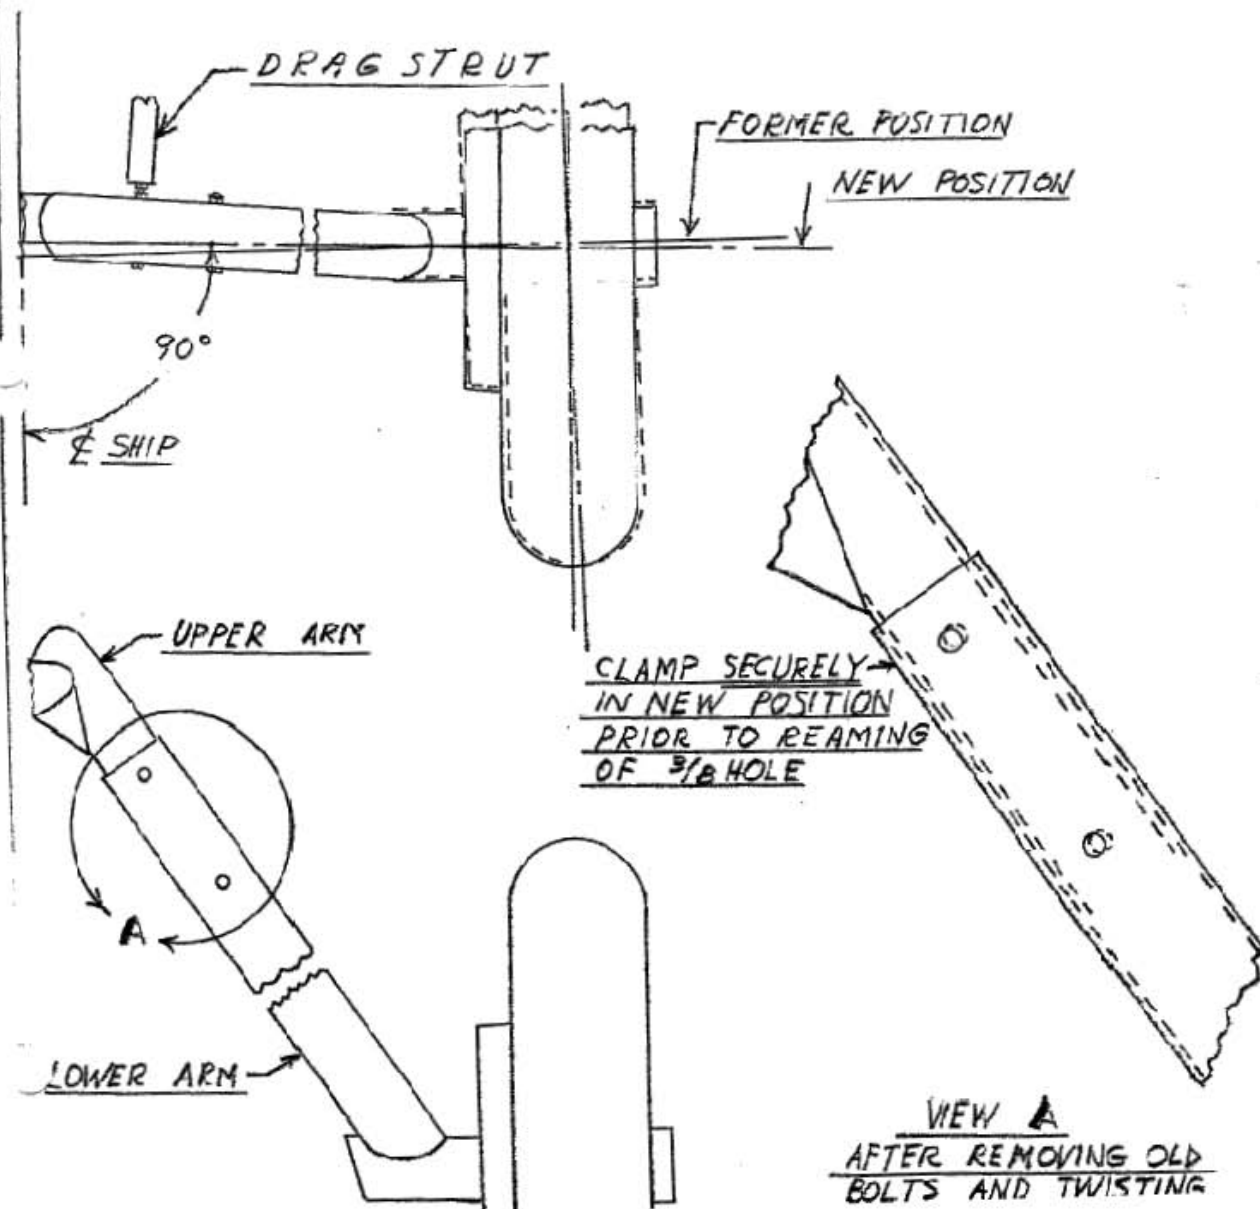
SKETCH
REWORK INFORMATION
CORRECTING EXCESSIVE TOE IN

A few aircraft were delivered with a certain amount of main landing gear wheel toe in which has now been determined to be objectionable particularly in operating from hard surfaced runways.

1. Raise the aircraft in such a manner as to free the gear from all weight.
2. Remove the four (4) 5/16 bolts attaching the upper and lower arms.
3. Remove drag struts.
4. With the aircraft in approximate flight position turn the lower arms of the gear until the center line of the axle forms a 90° angle with the center line of the ship. It will be noted that the 5/16 holes no longer line up. (See Sketch).
5. Clamp the upper and lower arms securely in this new position and ream the 5/16 holes to 3/8.
6. Install the new drag struts using the new standard attaching parts. (New drag struts have been tapped to accommodate AN6 bolts).

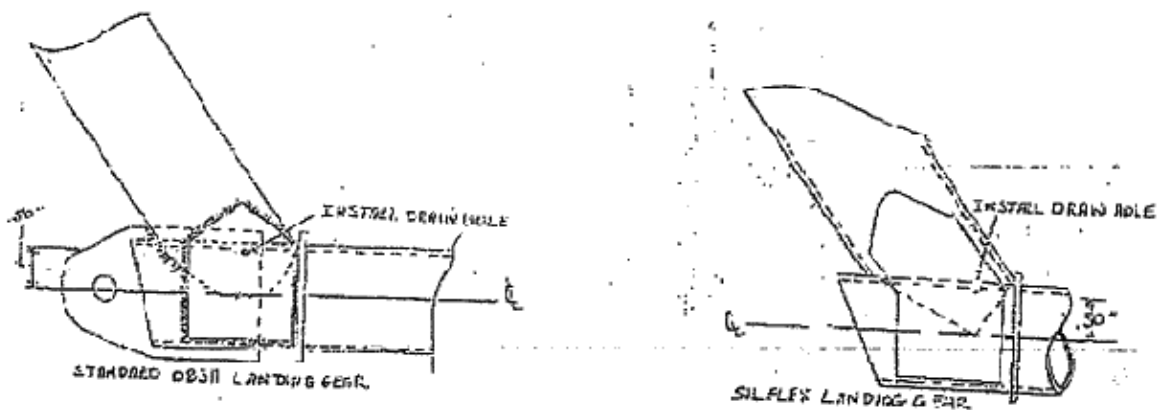
FIGURE A

Background: NTSB and several owners have reported failure of the main landing gear leg within the 2" area just above the axle weldment (see fig A). Corrosion damage in this area can be exacerbated by loose attachments and fittings to the gear leg which can lead to metal fatigue. The past few years of Luscombe operations have been punctuated by owner/operator reports of rust damage, or in several occasions, complete failure of the lower main gear leg from corrosion just above the axle shaft weld joint. Mechanics in the field have also reported "weld" repairs to gearlegs which are not authorized on Luscombe landing gear.

Condensation within the gear leg lets moisture accumulate in the sealed leg between the axle tube and the first hole up the leg where the brake pulley mounting bolt pierces the assembly, which makes this section particularly susceptible to corrosion.

Compliance procedure: Remove the gear fairings as necessary to gain access to the lower gear leg area for inspection. Locate the reinforcement patch on the rear side of the gearleg and centerpunch the reinforcement as noted on figure A. Drill the reinforcement and gearleg with a small hole (1/8") in the center of the reinforcement patch area where the upper leg joins the axle, just slightly (1/2") above the axle centerline. This drain hole at the rear of the gear leg will allow any trapped moisture to drain from the leg and minimize corrosion to this area. It will also allow some "drying air" access to the area to keep corrosion to a minimum.

Inspect: Inspect the area and note any water draining, or rust dust/flakes that might come out on the drill or a wire inserted into the hole. Use a small ballpeen hammer and scratch awl or punch to prick the base of the upper gear leg above the weld. If you are able to pierce the tubing, replace the lower leg with a new unit. Legs with no water or rust indicated may be returned to service. If there is any question as to the integrity of the leg, complete items 1-3 below. Treatment in accordance with #3 below is advised. NOTE: Inspect for weld repairs to the gear leg. Weld repairs to the gear leg is not an approved procedure. Components containing weld repairs are considered UNAIRWORTHY and must be removed and replaced because welding destroys the heat treat properties of the part.
