THE DON LUSCOMBE AVIATION HISTORY FOUNDATION

Luscombe Silvaire Model 8 Aircraft Type Certificate Holder

SERVICE RECOMMENDATION #2

December 15th, 1993, REVISED September 9, 1997

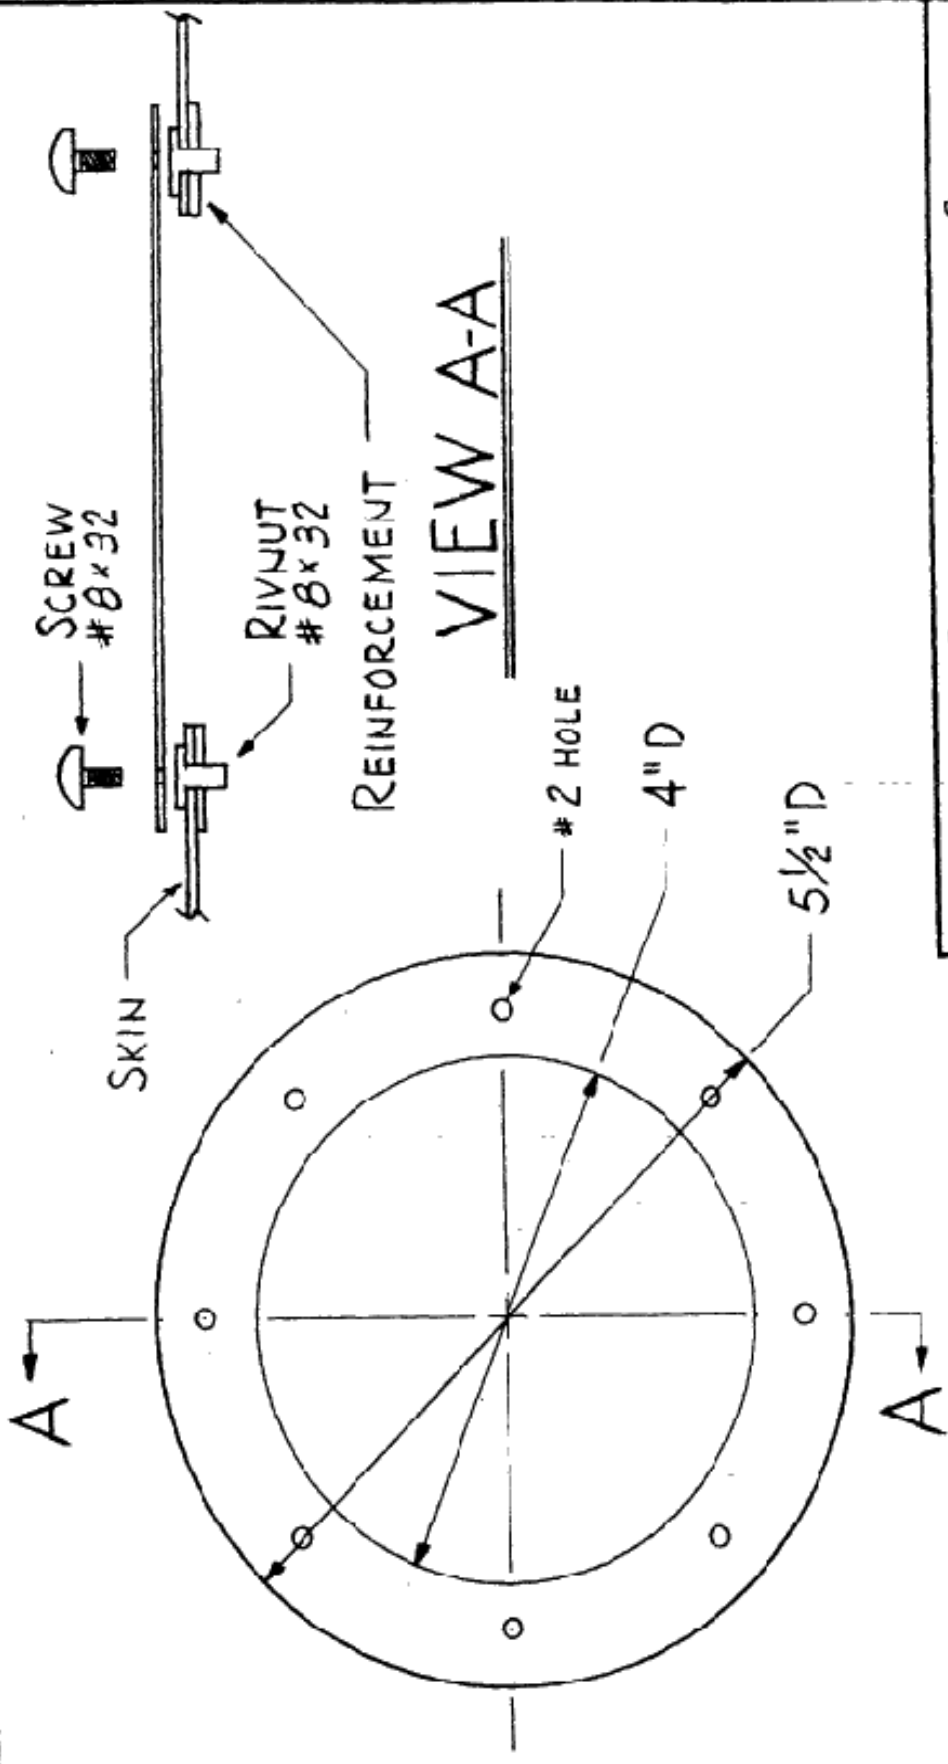
SCALE: N.T.S.	APPROVED BY:	DRAWN BY: D.J.W.
DATE: 11-16-93		REVISED
ADDITIONAL WING INSPECTION ACCESS HOLES		
ACCESS HOLE REINFORCEMENT	DRAWING NUMBER SK 18 PP2

Purpose: To facilitate the visual inspection of the internal wing front and rear spars for corrosion. This area is not readily visible in metal wings during routine maintenance due to a wing design defect; and the original manufacturer's failure to install routine inspection access to the internal wing areas. Service history of some of the Luscombe Model 8 series wings have shown intergranular corrosion in the spar extrusions. Other contamination and corrosion have also been discovered in many instances.

Install two (2) additional wing inspection holes on each lower wing surface per DLAHF drawing SK 18, pp1 & pp2, (attached).

- a. Measure and mark the location center for one additional inspection hole midway between the spars on the lower surface of the wing, 44 inches outboard of the wing butt rib.

- a1. Using the doubler included in the DLAHF kit #8007 as a template, mark the location for the inspection hole diameter, as well as the rivnut locations, on the wing skin.

- a2. Cut out the inner diameter of the inspection hole from the wing skin.
 - a3. Drill the rivnut locator holes as marked using a #30 drill bit.
 - a4. Insert the doubler through the cut out by gently bending the doubler between thumb and forefinger.

- a5. Relocate the doubler inside the skin and align the cutout and locator holes. Hold it in place temporarily with clecos or PK screws.
 - a6. Drill through both the skin and doubler using a #2 drill bit.

- a7. Insert rivnuts in the #2 holes using the appropriate tooling.
 - a8. Enlarge the coverplate holes to align with the rivnut location and screw size using a #16 drill bit.

- a9. Attach the coverplate with the screws provided, in accordance with drawing SK 18pp2.
- b. Measure and mark the location for one additional inspection hole forward of the leading edge spar on the lower surface of the wing, 64 inches outboard from the butt rib and centered at least 4 inches forward of the spar rivet line. To install the second inspection hole, (steps b1 through b9), repeat steps a1-a9 at the second location.
