AIRCRAFT CONTROLS & CABLES

7-149. CABLE SYSTEM INSPECTION.

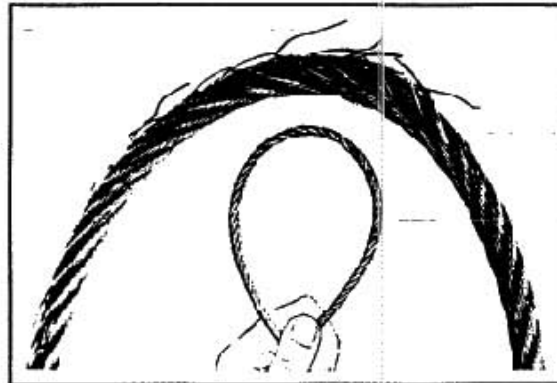
FIGURE 7-16. Cable inspection technique.

must be made since a broken wire will not always protrude or stick out, but may lie in the strand and remain in the position of the helix as it was manufactured. Broken wires of this type may show up as a hairline crack in the wire. If a broken wire of this type is suspected, further inspection with a magnifying glass of 7 power or greater, is recommended. Figure 7-16 shows a cable with broken wires that was not detected by wiping, but was found during a visual inspection. The damage became readily apparent when the cable was removed and bent as shown in figure 7-16.

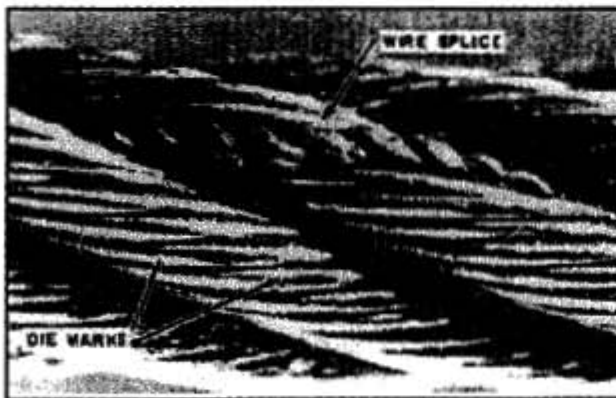
FIGURE 7-22. Manufacturer's wire splice.

7-151. WIRE SPLICES. Standard manufacturing splices have been mistaken for defects in the cable because individual wire end splices were visible after assembly of a finished cable length. In some instances, the process of twisting outer strands around the core strand may also slightly flatten individual outer wires, particularly in the area of a wire splice. This flattening is the result of die-sizing the cable, and does not affect the strength of the cable. These conditions (as shown in figure 7-22) are normal, and are not a cause for cable rejection.
