**THE LUSCOMBE ENDOWMENT, Inc.**

**SERVICE INFORMATION for the FUSELAGE TANK AND GAUGE SYSTEMS**

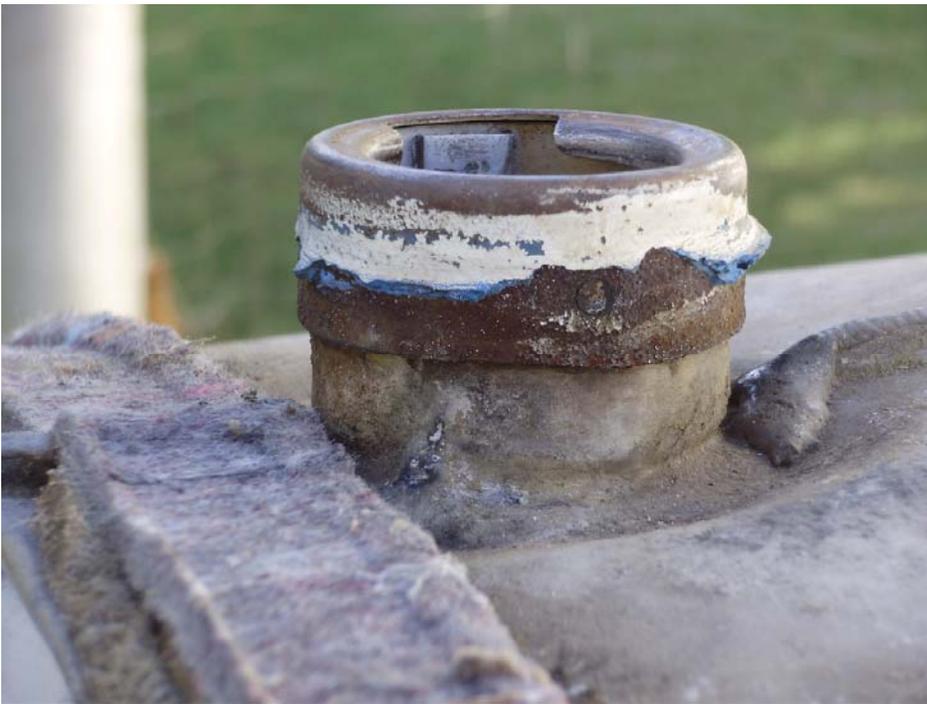
All Luscombe fuel tanks were originally constructed with a small aluminum filler neck that was then RIVETED to a steel filler bung that fit over this small neck, on to which the vented fuel caps screwed.

Sealing between the bung and the aluminum neck was almost non-existent, leaving a vent space that would allow the pressure cap to vent past the neck and in to the interior of the airplane.

This un-intended ventilation will / does siphon vaporized fuel (and fuel odor), into the cockpit both on the ground and in the air.

On all tanks that we repair, overhaul, or have built, the Luscombe Endowment and Classic Aero removes the old filler neck assembly, and we weld a new aluminum female bung into the hole, creating an air-tight tank seal which retains the vent vapors into the tank.

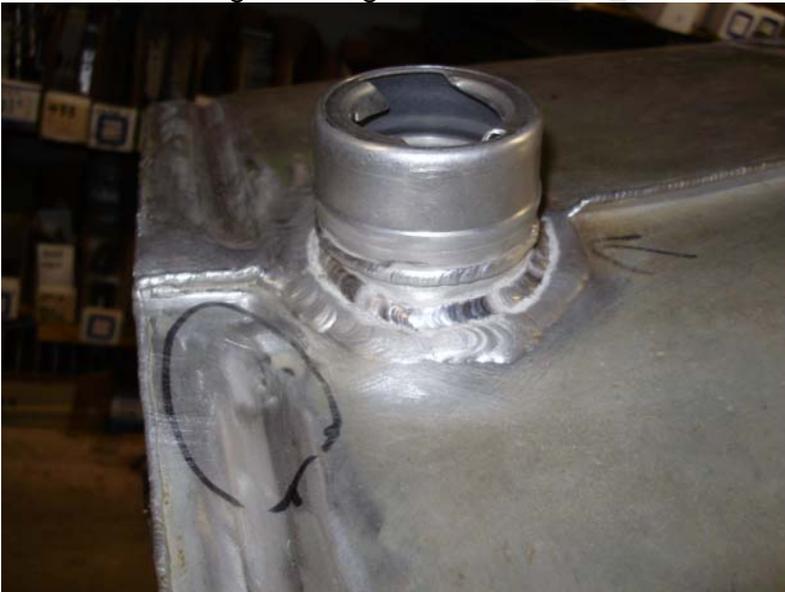
This welded joint prevents the pressurized vent air from flowing into the vented tank, and past the riveted bung attachment, and carrying with it fuel vapors from the tank vent space into the cockpit.

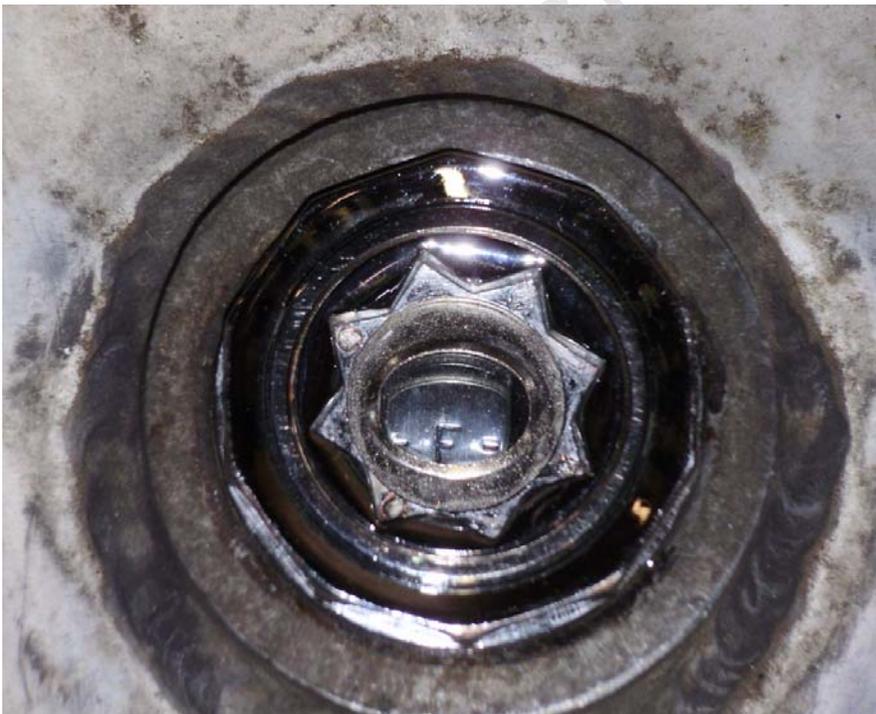
The **Ford style** Luscombe gauge is similar to the Ford model 'A' installation.

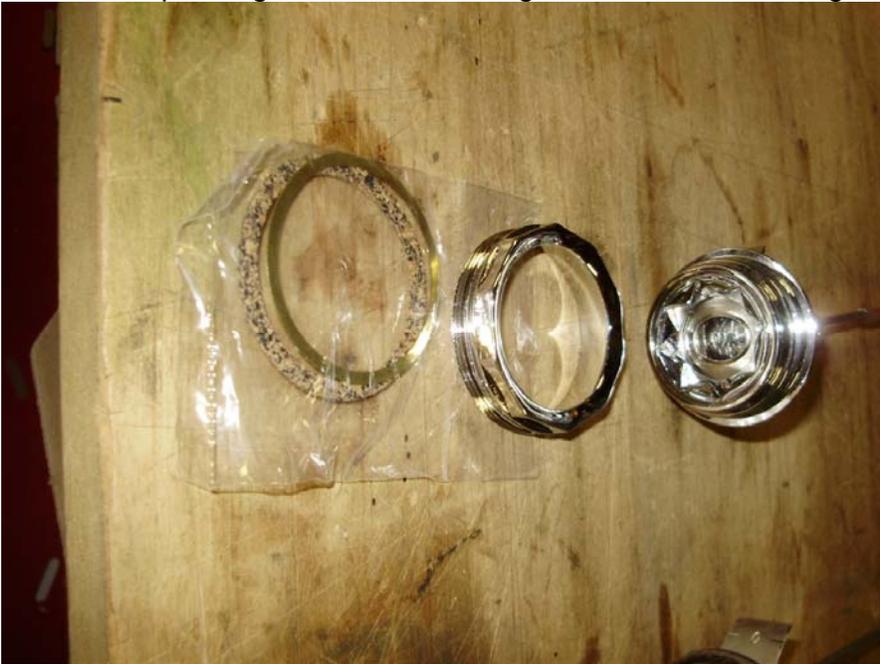
Attachment is by a 12 point threaded nut, against the gauge, with brass slip ring, against a cork or neoprene gasket that seals against the welded bung.

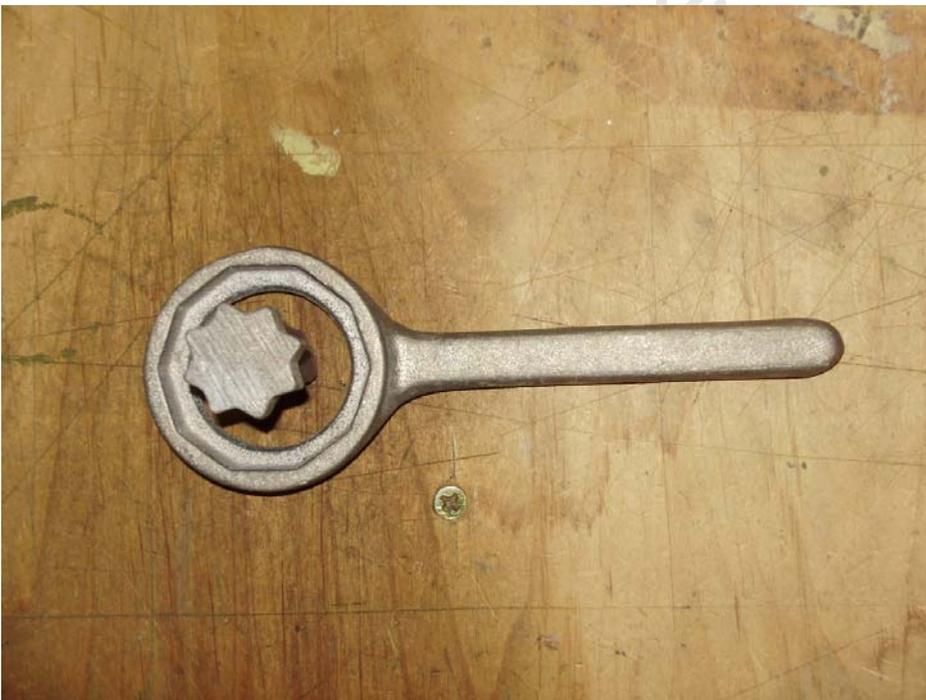
A special external (aluminum) wrench is used to tighten the retainer nut, while an internal wrench is used in the sight glass to hold the gauge vertical to the tank.

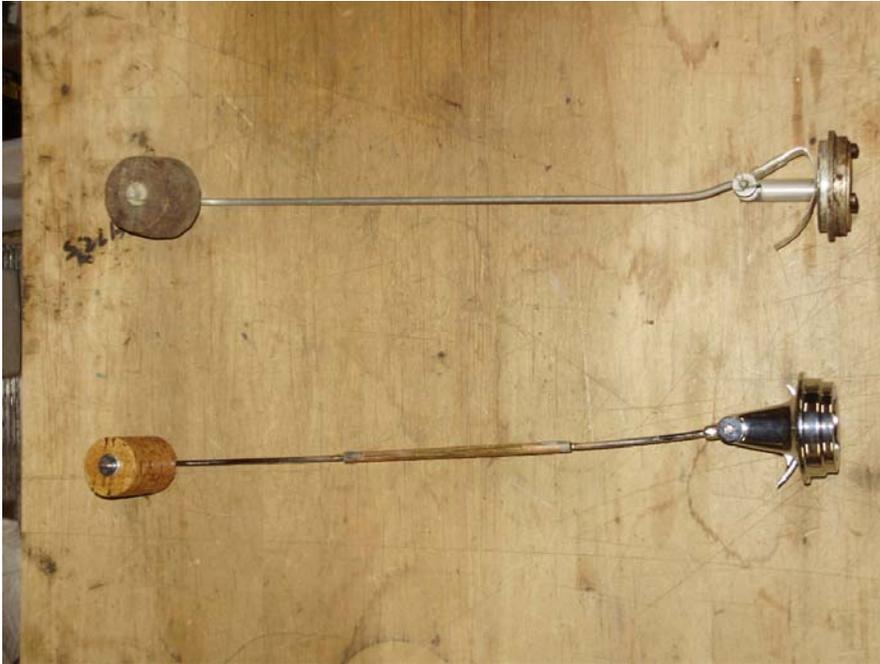
THE TOP GAUGE IS A HARDING UNIT- side view;  
THE BOTTOM UNIT IS A MODIFIED FORD STYLE GAUGE.

The properly modified gauge to meet the Luscombe print requires a template extension of the float arm to make the indicator arm longer. The use of a properly modified gauge will then give fairly accurate fuel indications, though I still would rely upon a clock, and consider the gauge nothing more than a plug to keep fuel out of the cockpit. Both Classic Aero and Univair have the properly modified fuel gauges for the fuselage tanks for about \$90.

Simply installing an un-modified indicator will only plug the hole in the side of the tank, and results in no accurate gauge readings because the short arm shows full for about 1.1 hours, and empty for about 1.3 hours, and is accurate at  $\frac{1}{2}$  tank for about 30-45 minutes of flight. Properly modified and accurate gauges built to the Luscombe prints dimensionally, can be obtained from Classic Aero at 480-650-0883. (A similar FORD style indicator is used in the very early 11.5 gallon wing tanks, except in that wing installation the float arm is shortened considerably to match the tank profile.)

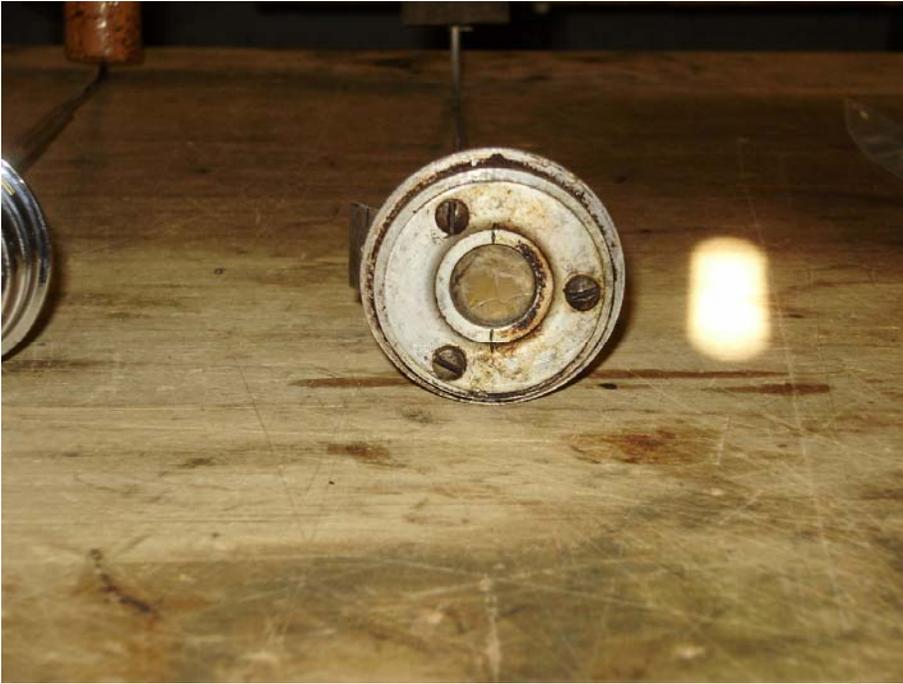
The second style of fuselage tank gauge is the "Harding" gauge which can be identified easily by the three small screws in the gauge face-plate. These screws retain the face plate into the gauge body.

**PICTURE IS A TYPICAL HARDING GAUGE-  
NOTE THE STAINED AND CHIPPED PLASTIC FACEPLATE**

The operation of the Harding unit is similar to the Ford style, but installing that gauge is more complex, there are fewer / no parts, and very little support to repair the gauges. If one intends to use this gauge, it will be necessary to fabricate all of the gaskets AND a new faceplate to make repairs. Generally one is better to replace the Harding gauge with a Ford style gauge of better quality, which is readily supported, and more versatile.

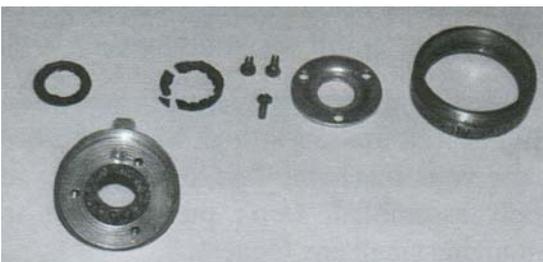
Similar to the FORD gauge, the Harding gauge is held in with an external nut that is rotated by two spanner pins, or more often, a vice grip or a medium sized plumbers pipe wrench.

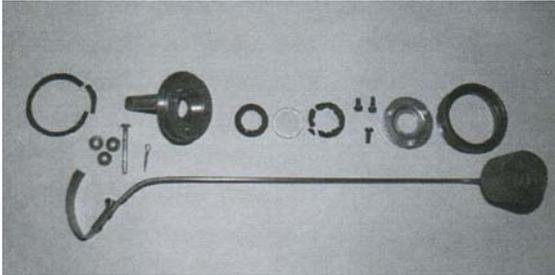
When removed, the Harding gauge displays many more parts, most of them fragile and or worn out.

Because ALL of the Harding parts are of poor quality, No one has elected to support or to re-sully them, because of the cost, versus benefit & risk of repairing a marginal system while the Ford system components are available and cheap, with proper drawings for their use, and nothing of that sort exists for the Harding gauges.
